We've recently discovered a potential issue with the D-shaped hub connection in our **Mechanical Dump Valves and Trunnions**. The tolerances applied to the newly designed hub-to-shaft (or hub/shaft) connections were too loose, allowing for greater play at this D-shaped connection than is ideal.

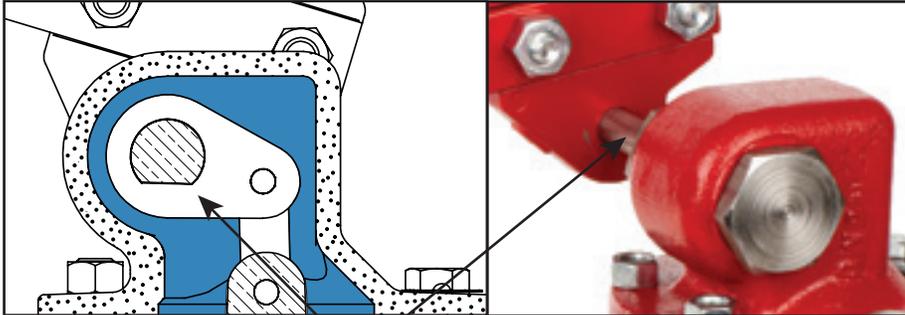
HUB-TO-SHAFT CONNECTION

However, some inventory was built up and sold prior to the correction. This means our customers could potentially face issues with range of motion in their trunnion/dump valve setups.

Specifically, as the float reaches its fully UP position, this might not be enough to fully open the valve, due to the amount of play in the D-shaft/hub connections. This is a potential performance issue, not a safety issue.

We have quickly corrected this issue by tightening the tolerances (making the shaft dimensions larger).

The solution for affected valves and trunnions is to replace the shafts with new shafts that have a larger dimension, as mentioned above.
