MISSING BEVEL ON 522 UPPER STEM

Potential Issue with High Pressure Control Valve Upper Stems

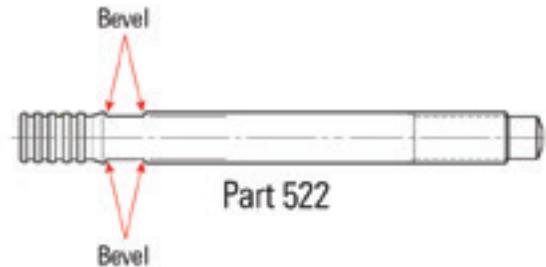
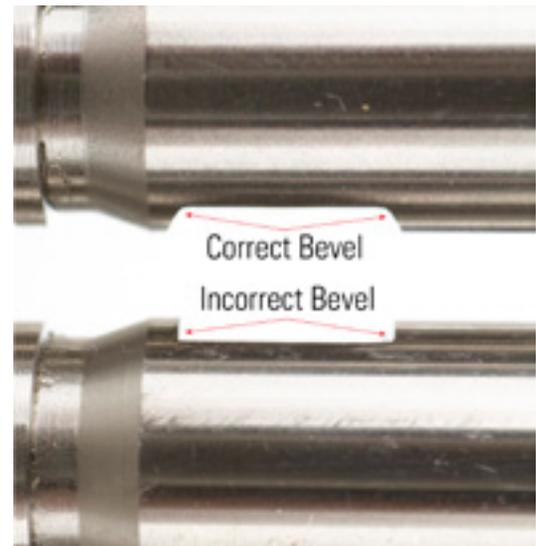
We've recently discovered a potential issue on our 2" High Pressure Control Valve. The valve is missing a bevel located above and below the wrench flats on the 522 upper stem. This lack of a bevel can cause damage to the o-ring when it's installed.

The potential operational issue this could cause is a leak of supply gas.

We recommend that you immediately inspect your inventory and any active valves that were shipped after June 26th, 2019 for this defect.

Products manufactured after July 23rd, 2019 have had this issue corrected.

If you discover any affected products, please contact your local authorized distributor or Kimray store with the number of replacement parts you need.
