# **GAP CONTROL TO REPLACE 12PL**

## INTRODUCTION

A producer in Potrero del Llano field in Poza Rica, México, needed to replace the obsoleted 12PL Pilot on some of their production separators.

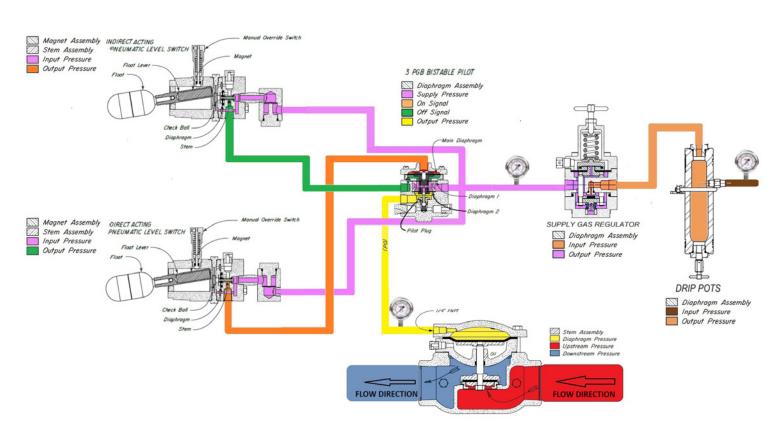
Vessel Type: Vertical 2-Phase Separator

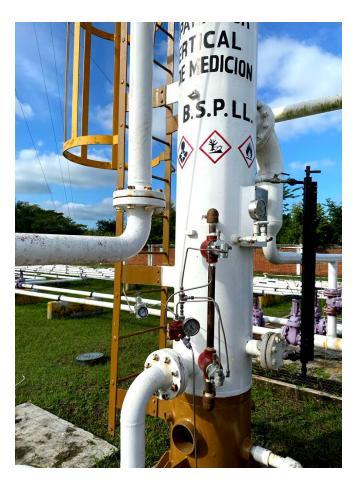
To incorporate this, they installed 2 pneumatic level switches—one direct and one indirect—operated with a 3 PGB Bistable pilot to operate the existing 4" low pressure control valve.

Both pneumatic switches were installed together with 2 external float cages using 1" pipe tubing and connected to existing 1" connections on the vessel.

In order to provide better control on the pneumatic system, a drip pot and supply gas regulator were installed with pressure gauges on the line to monitor the pressure between the pilot and control valve.
