FIELD ANALYSIS REPORT

KIMRAY
INC.®

SEVERE WASH-OUT THROUGH SEAT AND BODY

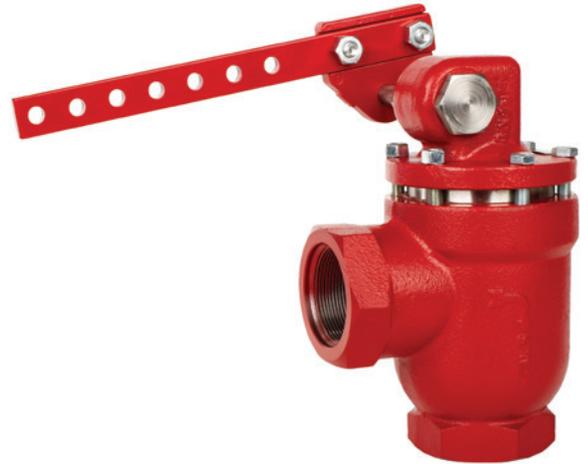
It was observed that the serial number and name plate indicate that the valve is a diaphragm-balanced valve rated to 175 psi. **The body of the valve is rated for 500 psi and does not come from the factory with the 212 SOA bonnet.** There is a risk associated to valve operation and personnel safety when this assembly is exposed to more than 175 psi. We would recommend checking existing stock and active operations to remove any of the found assemblies from service

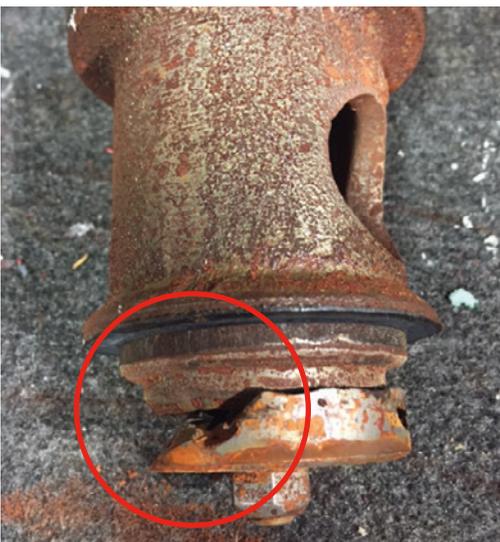
Image A1

The root cause of the failure was the sand separator being bypassed allowing excessive sand or other particulates in the process fluid causing accelerated erosion. The seat, seat disc, and ratio plug developed a leak path which continued to get bigger (Images A1-4).

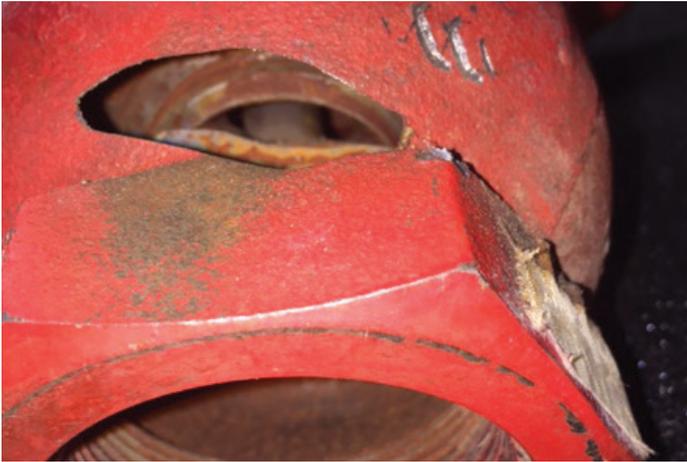
Image B

The fluid, along with sand flowing through the hole, was directed towards the side of the body and eventually created a leak path in the valve body (Image B).

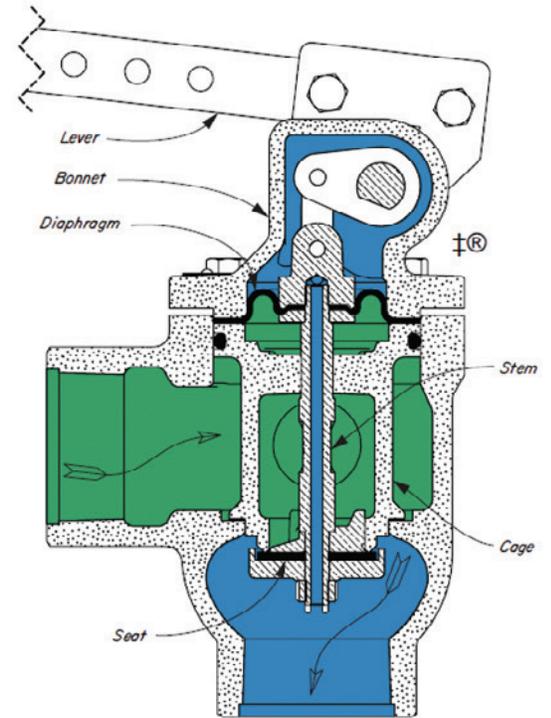
The **Diaphragm-Balanced** version, which was being used in this application, is a good, lower-cost option for normal conditions where erosion is not an issue, but due to the action of the seat, which drops down as it opens, staying in the flow path, it is not suited for erosive conditions.

Kimray Diaphragm-Balanced Valve

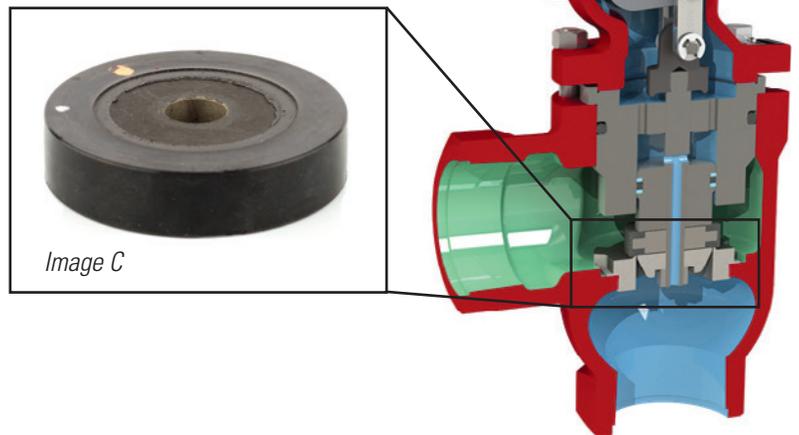
Image C

Kimray Piston-Balanced Throttling Valve

Kimray offers a **Piston-Balanced Throttling** version where the seat and ratio plug lift up, out of the way of the flow path. This design withstands erosive conditions much longer. The shape of the ratio plug allows for a balanced, less intrusive point of process control. Additionally, Kimray has redesigned the seat to be HSN bonded around a stainless steel core, creating a robust reversible seat (Image C).
