# T-BODY HIGH PRESSURE CONTROL VALVE & CARBIDE TRIM FOR EROSIVE SERVICE

In this field study, we'll show how the valve performed at a site in Western Oklahoma.

# WESTERN OKLAHOMA

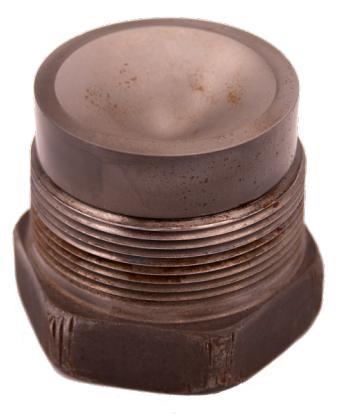
6 month old wear plug

At the 6-month mark, the Kimray team replaced the plug for examination, and discovered the plug was only 37% worn through the plug despite 6 months of operation in the high volume of high-velocity sand.

Whereas they had been replacing trim or bodies every 30-90 days before, after 6 months of operation the T-Body High Pressure Control Valve was still in good operation. The T-Body's wear plug, made of hardened D2 steel, was much more robust than the previous valve bodies where failure was experienced. The plug is threaded in and sits exactly where the previous valve bodies were being compromised.
