## 3" TREATER VALVE STUFFING BOX

### Reverting to Original Stuffing Box Design

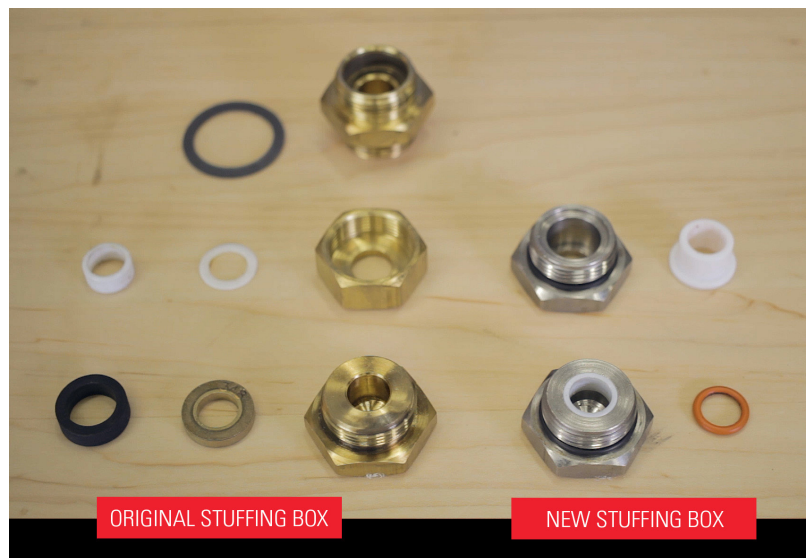
This product notice is to inform you that some 3" Treater Valves with new stuffing box design assemblies are leaking out of the stuffing box/shaft o-ring seal at lower pressures. Our engineering and quality teams are working to quickly determine a root cause and design a solution.

Serial numbers with the new stuffing box design started with S/N: 2181530001. Based off of this serial number, please check your stock, and then let Jenny know how many replacements you need.

In the meantime, we are reverting back to the original stuffing box design on the 3" Treater Valves until a permanent solution can be designed and tested.

If you have current stock of 3" Treater Valves with the new stuffing box design, you can **contact Jenny Kennedy by email at [jkennedy@kimray.com](mailto:jkennedy@kimray.com) or by phone at 405-525-4298** to receive replacement stuffing box components. The same would apply if customers are having issues with their valves.
